## Release notes DAM

Versie: 18.1.3

Dit is de oplevering van de DAM, oftewel de DAM User interface (UI) met het rekenhart van DAM Engine.

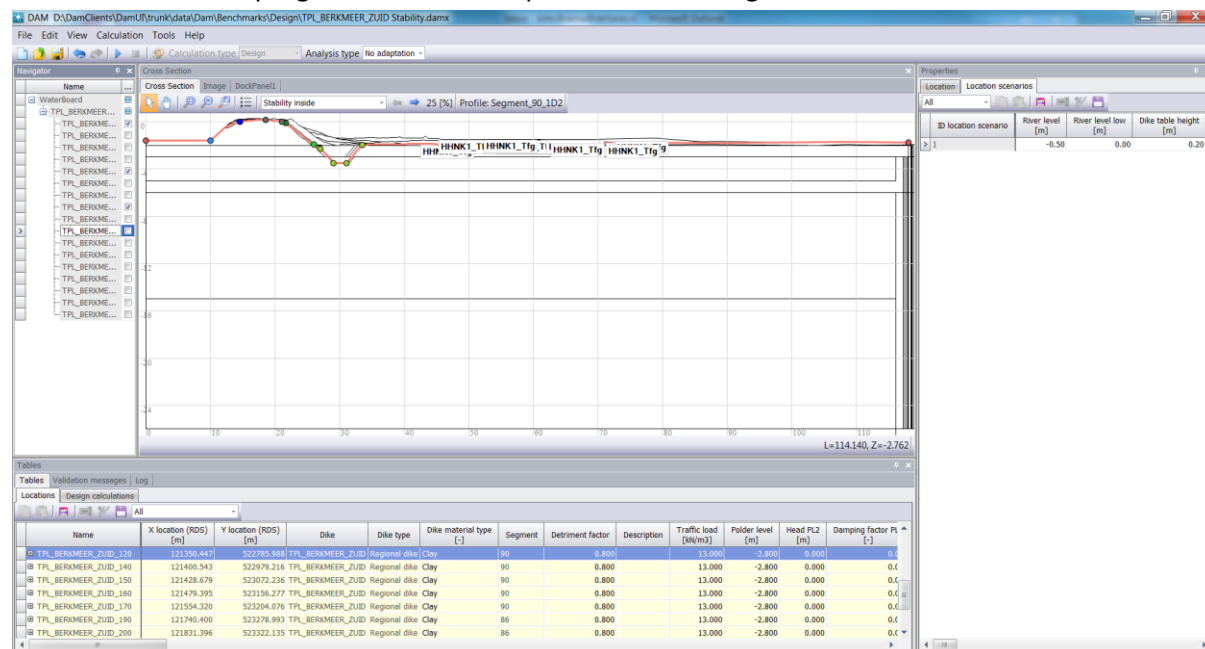
<sup>i</sup> Wanneer in de design modus meerdere locaties worden geselecteerd en vervolgens 'undo' wordt meerdere malen wordt gekozen, laat het programma in het dwarsdoorsnedescherf meerdere profielen tegelijkertijd zien.

Deze bug bestond al in DAM 15.1 (zonder melding), zie onderstaande afbeelding. Het verschil met DAM 18.1 is dat het programma nu vastloopt met een melding.

figuur Error! Main Document Only. Tekenen van meerdere profielen tegelijkertijd
